# INDEPENDENT LAB REPORT: Actual AC & DC Electrical Currents Measured on Conductive and Dissipative Flooring

ANSI 20.20 2007 | ANSI 20.20 2014 | ESD S7.1 | ESD STM97.1 | ESD STM97.2

# Electrocution Hazard From Conductive Carpet Tiles

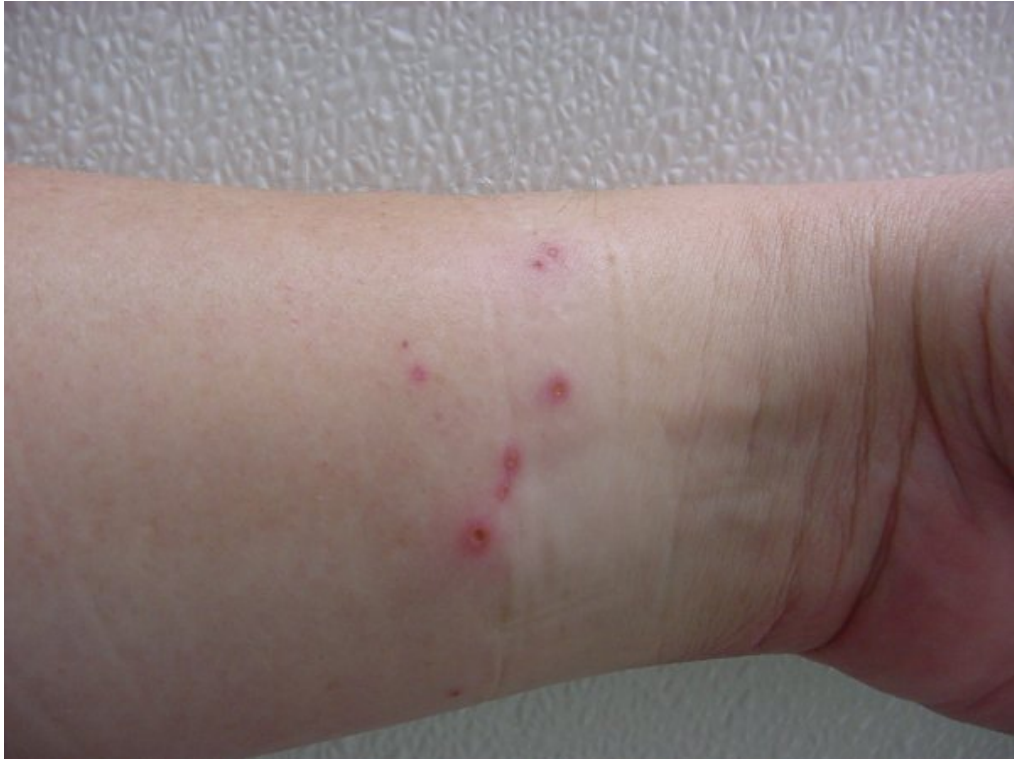
The above discussion is for known voltage sources with known paths through the body. When voltages are applied through unexpected paths, these numbers may be misleading. Even the current levels may be misleading: for example, during a round robin test for the ESD Association, 10 volts was used to determine the resistance of various gloves. No problems were encountered until conductive gloves were tested. Black conductive gloves when worn not only were conductive by the ESD Association's definitions but the hand hydrated the gloves making the connection to the body very intimate and low resistance. At 10 volts more than 1 mA DC was encountered. This current through the tender (no dead layer of skin) area of the wrist resulted in ruptured capillaries and burns - 1mA DC.

While this is on the level of accepted “threshold of perception” currents, it obviously caused physical damage. If this current was applied across a vital organ, the results would be more tragic.

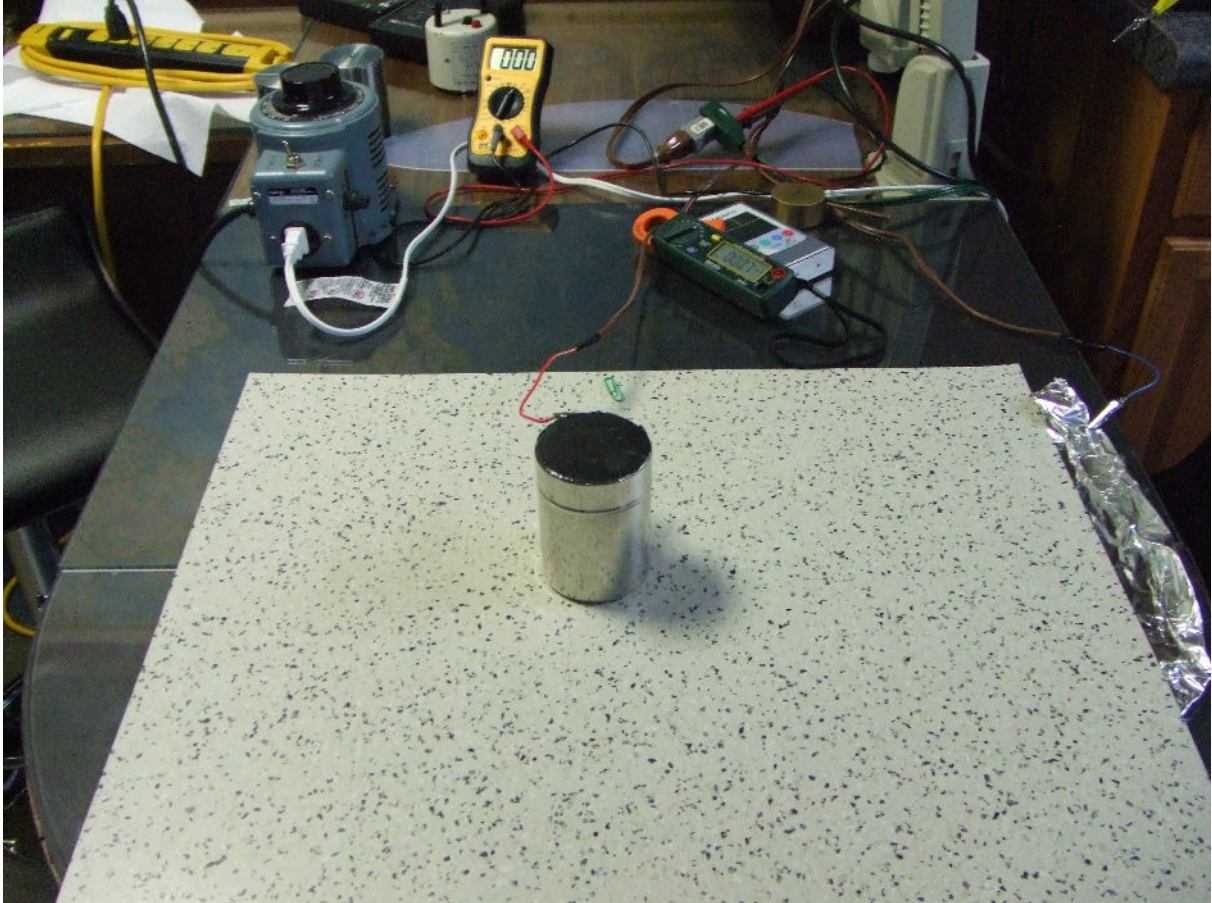
## Alternating Current Test Method

The following set up was used to determine the AC current to ground from the top of the carpet and rubber tiles.

The tile was placed on a large piece of aluminum foil. A 5-pound electrode was placed on top of the tile. The AC voltage was applied from the top electrode to the aluminum foil.

The voltage was controlled by a variac feeding a step up transformer. The voltage applied was measured with a standard multimeter. The AC current was measured with a clamp-on style ammeter.

The voltage was raised slowly and the volts recorded for several "milestone" currents.

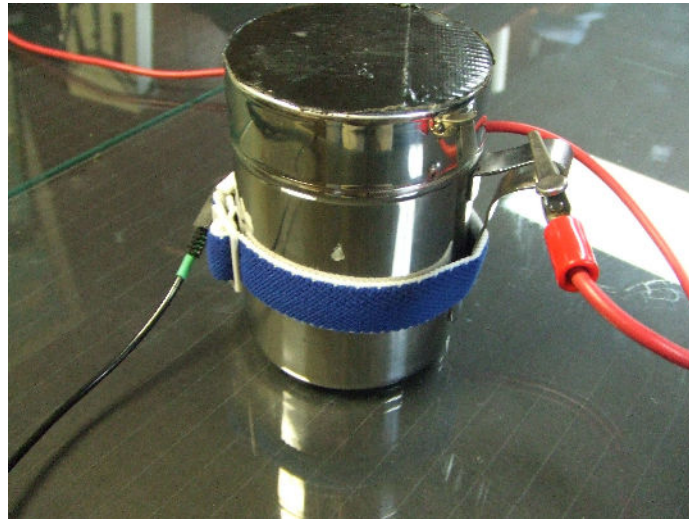
### 1 Meg Ohm Wrist Strap

The following Tests were conducted on a **1 Meg Ohm Wrist Strap**. The tests used alternating current voltages applied through the wrist strap to a metal electrode.

AC Volts Volts ac	AC Amperes mili Amps ac	AC Impedance Ohms
120.0	0.1	1.2E6
240.0	0.2	1.2E6

The threshold of perception is never reached.  
The "let go" current is never reached.  
Lethal currents were never reached.

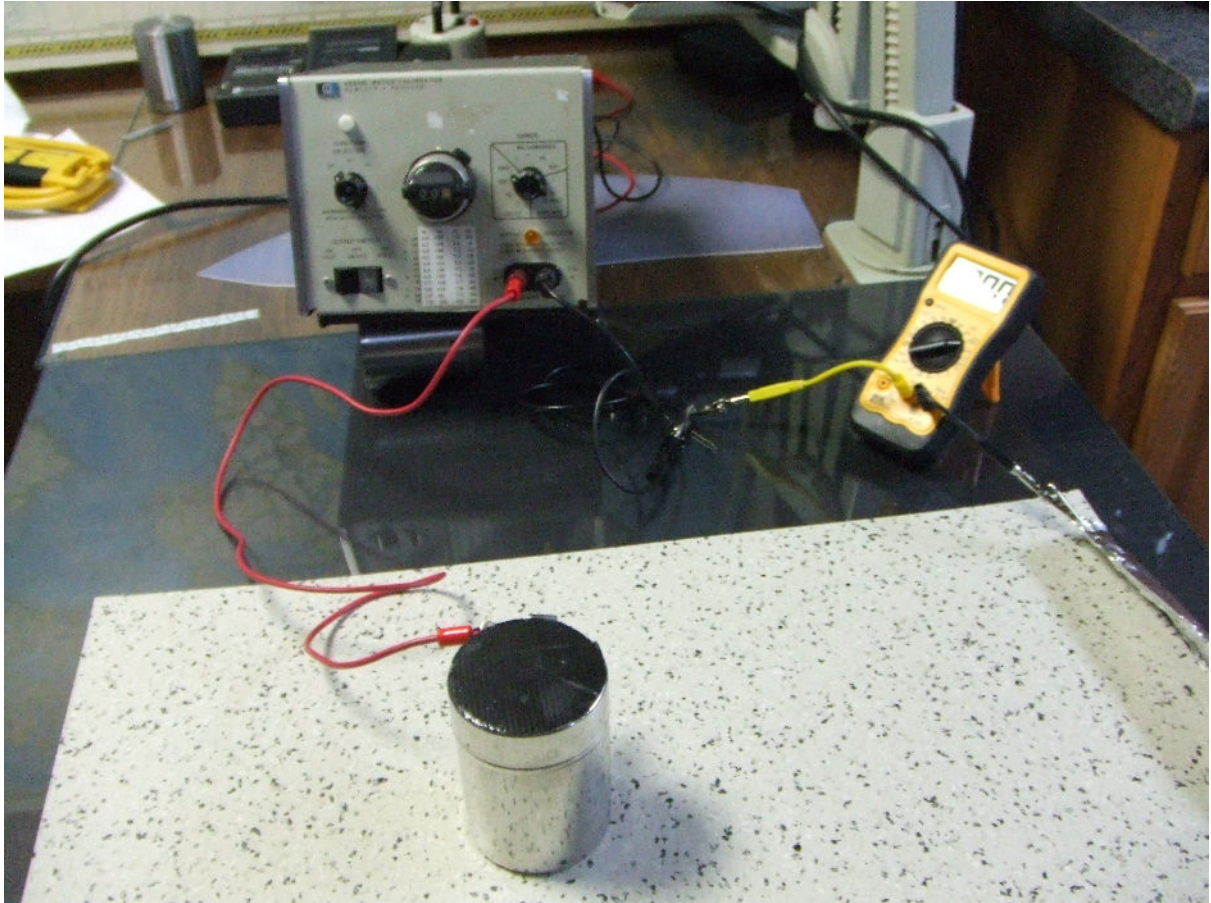
## Direct Current Test Method

The following set up was used to determine the DC current to ground from the top of the carpet and rubber tiles.

The tile was placed on a large piece of aluminum foil. A 5-pound electrode was placed on top of the tile. The DC voltage was applied from the top electrode to the aluminum foil.

The voltage was controlled by an HP Meter Calibrator voltage source. The voltage applied was determined by the calibrated dial readings. The DC current was measured with a standard multimeter.

The voltage was raised slowly and the volts recorded for several "milestone" currents.
