# Installing ESD Flooring Without Adhesives and Downtime

By Dave Long, Founder and President, StaticWorx, Inc.

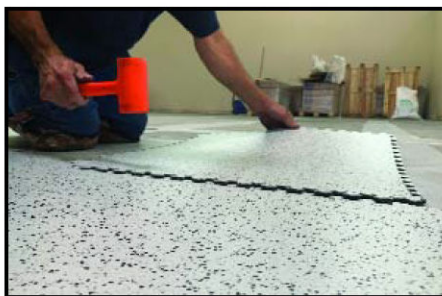
***Proper flooring is a necessary part of any ESD control program.***
